DEPARTMENT OF TRANSPORTATION

Contract #: 04-0120F4Cty: SF/ALA Rte: 80 PM: 13.2/13.9File #: 1.28**WELDING INSPECTION REPORT****Resident Engineer:** Casey, William**Address:** 333 Burma Road**City:** Oakland, CA 94607**Report No:** WIR-029788**Date Inspected:** 05-Jun-2013**Project Name:** SAS Superstructure**OSM Arrival Time:** 700**Prime Contractor:** American Bridge/Fluor Enterprises, a JV**OSM Departure Time:** 1730**Contractor:** American Bridge/Fluor Enterprises, a JV**Location:** Job Site**CWI Name:** As noted below**CWI Present:** Yes No**Inspected CWI report:** Yes No N/A**Rod Oven in Use:** Yes No N/A**Electrode to specification:** Yes No N/A**Weld Procedures Followed:** Yes No N/A**Qualified Welders:** Yes No N/A**Verified Joint Fit-up:** Yes No N/A**Approved Drawings:** Yes No N/A**Approved WPS:** Yes No N/A**Delayed / Cancelled:** Yes No N/A**Bridge No:** 34-0006**Component:** OBG**Summary of Items Observed:**

WELDING INSPECTION REPORT

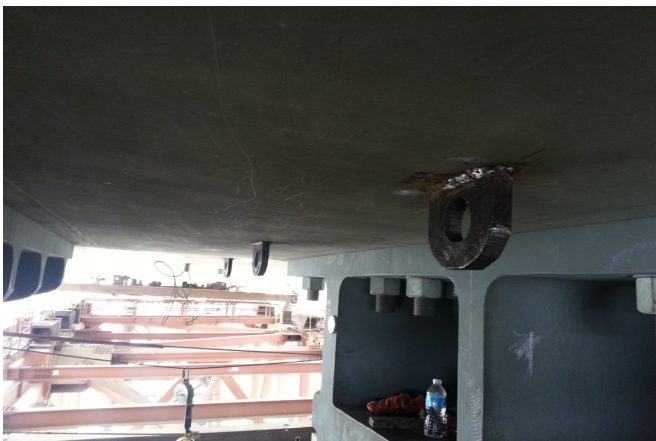
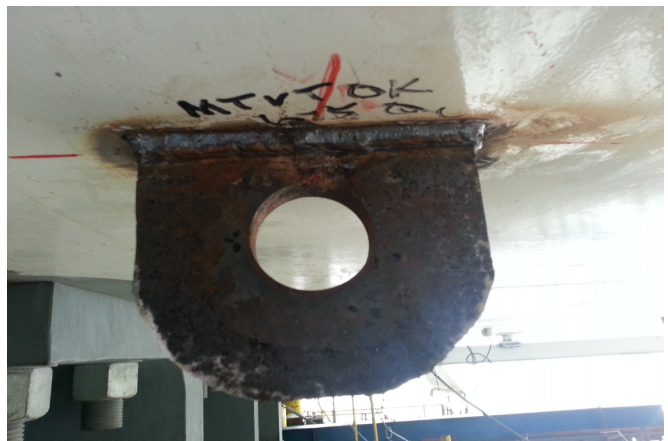
This QA Inspector randomly observed ABF welder Guo Wu Chen #1556 perform the Shielded Metal Arc Welding (SMAW) process in the 3G position on the Hinge "A" barricade joint. The welder was observed utilizing WPS ABF-D1.5-F1200A-Revision 2. The welder was observed preheating the surface area prior to welding and other welding parameters as inspected by the QC Inspector were recorded as 138 amperes and appeared to be in compliance with the WPS noted above. The QAI noted that no drawings or details were available and inquired of ABF Engineer Bill Sullivan who stated that details would be provided.

This QA Inspector randomly observed ABF welder Wai Kit Lai #2953 perform the SMAW process in the 4G overhead position on the shear key anchorage lugs at E2. The welder was observed utilizing WPS ABF-D1.5-F1200A Rev. 2 for Fillet welding. The welder was observed preheating the surface area prior to welding and other welding parameters as inspected by the QC Inspector were recorded as 136 amperes and appeared to be in compliance with the WPS noted above. The QA Inspector made subsequent observations throughout the shift to monitor quality and noted that the work was in progress and appeared to be in general conformance with the contract documents. RFI-003331R00 was referenced during this observation.
